Service Bulletin

Object: **Clutch update**

Product: **Turismo Veloce (all versions)**

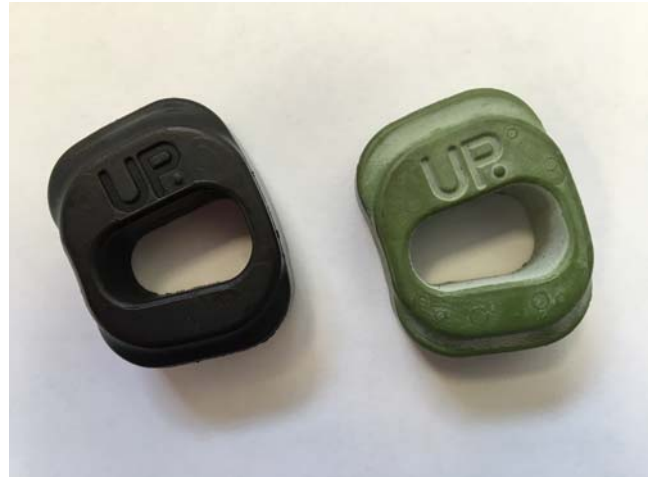
- *Replace the rubber cush drive (lubricating them with engine oil to facilitate the insertion) with new type ones, black and green included in the kit as shown in the picture:*

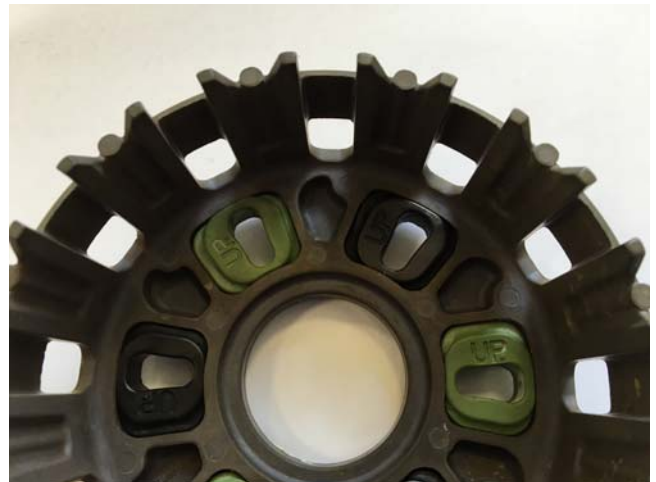
- *Place the new rubber cush drive on the clutch housing with the inscription "UP" upwards, and alternating the two colors (black - green) as in the picture:*

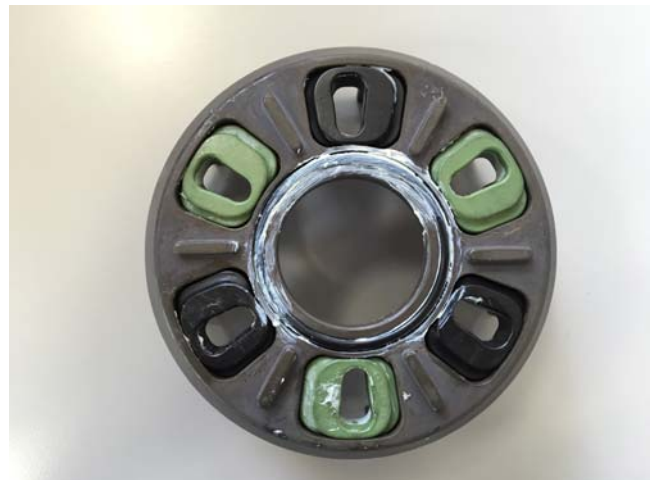
- *Assemble the clutch housing making sure that the O-ring does not get pinched in between, using some grease in order to keep it in place as picture:*

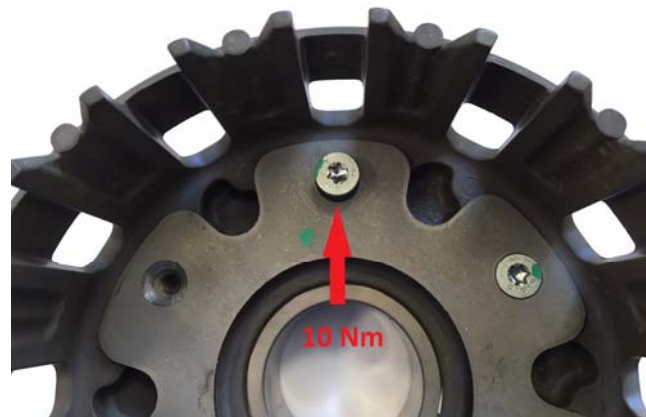
- *Reassemble the clutch housing, fixing the plate with the 6 screws and using some medium Loctite on the thread tightening them to 10 Nm as picture:*
